An Experiment in Archeological Site Stabilization—Part II

Cumberland Island National Seashore

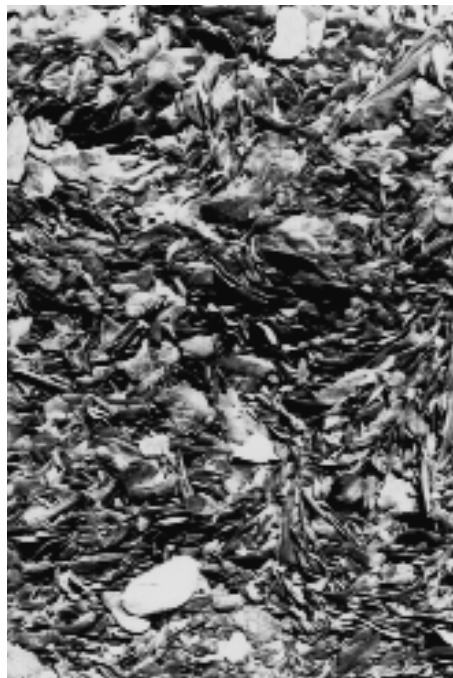
Fig. 1. Plan view of interlocked oyster shell on naturally occurring rake.

shell, tightly compacted and cemented with silt (figure 1), provides an erosion resistant armor on the active wave side while allowing water trapped behind it to filter through.

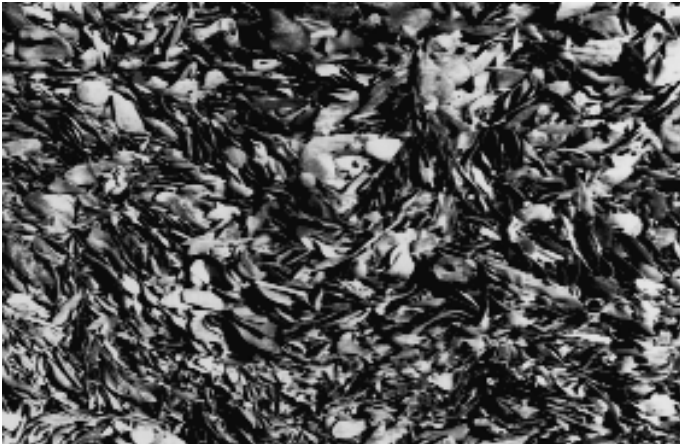
Fig. 3. Plan view of interlocked oyster shell on artificial rake.

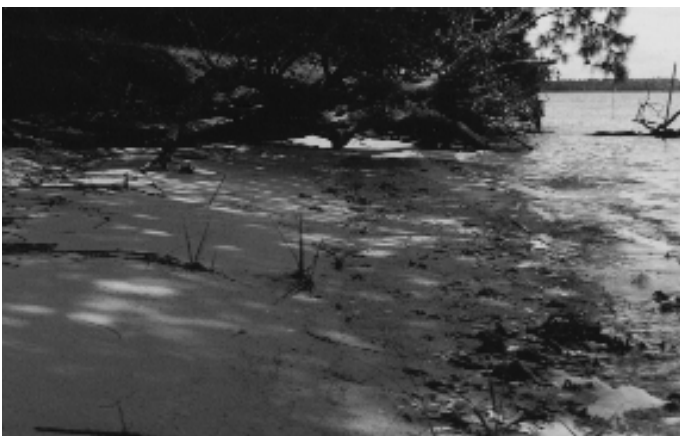
Fig. 5. Artificial rake, June 1992. Rake is the low curving rise on the right hand side of figure. Note accretion of sand and grasses beginning to grow.

The project area was visited periodically throughout 1991 and 1992. We are pleased to report that the artificial rake has indeed performed like its natural counterparts. In fact it has worked so well that in June 1992 it was difficult to determine the exact location because the silt accumulations had completely buried the rake (figures 4 and 5). Bank erosion behind the rake was noticeably curtailed and

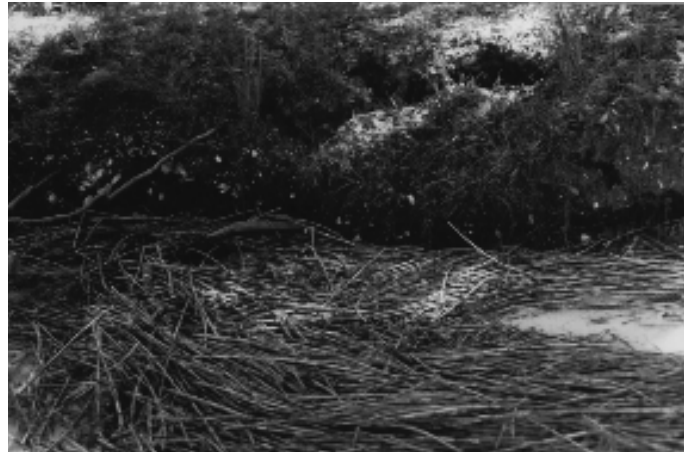
Fig. 6. Detritus and sand accretion along cut bank.

over 2 1/2' of silt deposits were measured. The buffering action of the rake was providing a healing mechanism along the cut bank. The land surface has built up enough that tidal submersion has been minimized. Vegetative detritus accumulating along the cut bank provides an additional buffering action (figure 6). This protects the micro-environment and helps several species of marsh grass become established.

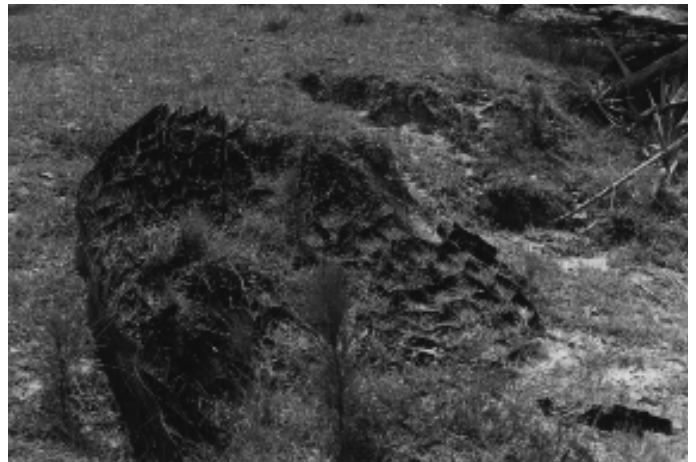
Fig. 7. GEOWEB place in animal trail along cutbank. Note pine seedlings.

The hoped for natural invasion of marsh vegetation (Ehrenhard and Thorne 1991) is beginning to occur. However, continued use of the area by campers and grazing horses have impacted the rate of revegetation. We are pleased to see that the GEOWEB has completely eliminated incursion by horses and pigs in the areas where it was placed. The GEOWEB is firmly interwoven with native grasses and, in some cases, is harboring small pine trees; these have rooted naturally in less than two years (figure 7).
